Our AGW +2 base plates for the Beretta 80 series double stack pistols are made to the highest standard of quality and designed to fit tightly to the magazine body in order to ensure the greatest amount of reliability possible. As such, the small ball of slag found on the base plate lips can make our plates extremely difficult, if not impossible to install. Fortunately, removing this flaw is fast and easy.

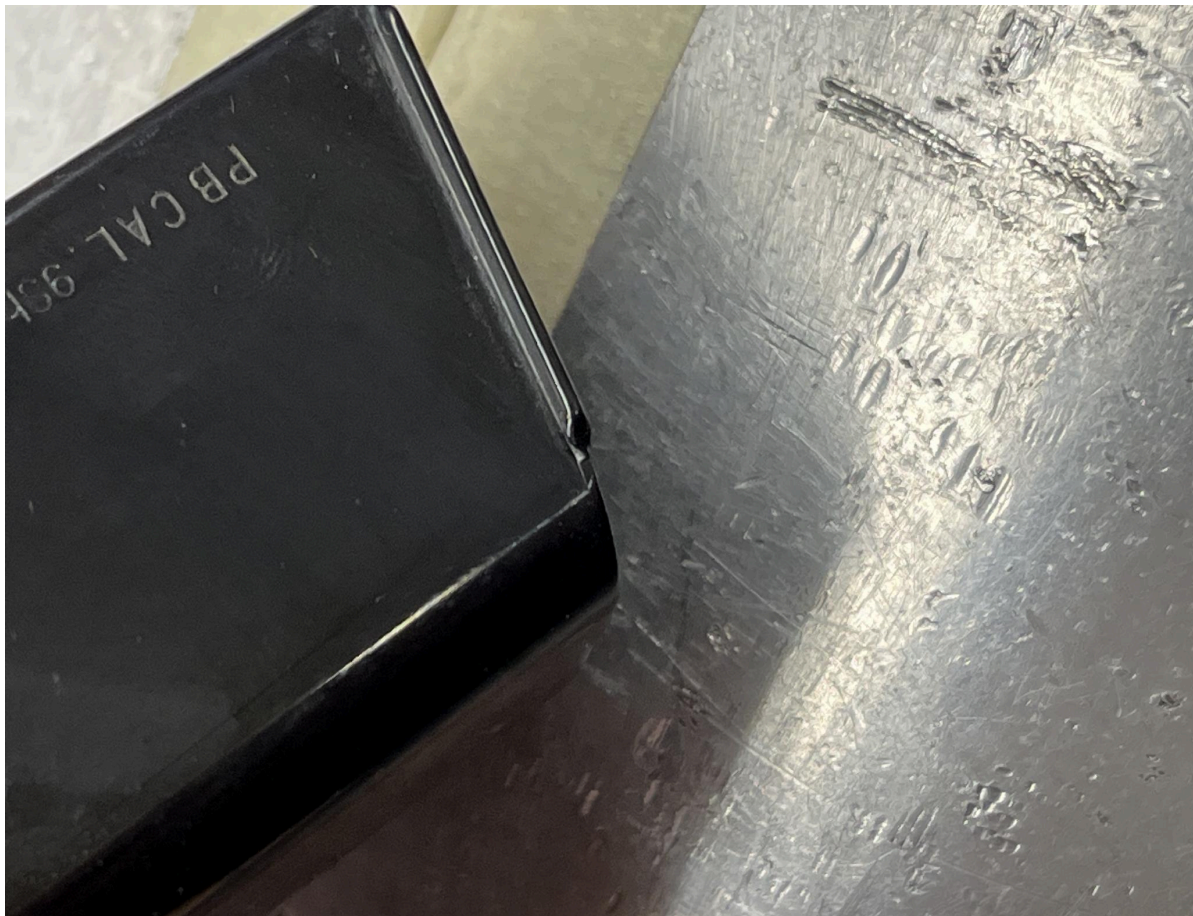
As you can see in the below photo, there is a bit of metal at the beginning of the lip that increases the thickness of the metal by nearly half again the original thickness. This is more than enough to cause fitment issues with our plates.

If you find your base plates difficult to install, simply remove this edge using a small needle file, or even a metal nail file. Scrub the offending area until the leading edge is the same thickness as the rest of the lip. Test fitting the plate as you go until it slides on with little to no effort and once complete, simply install the plates normally.
